**Yellow Floating Heart Eradication From Two Storm** Water Ponds Near **Delavan Lake** Heidi Bunk, DNR Lakes **Biologist** Audrey Greene, Walworth **County Lakes Specialist**

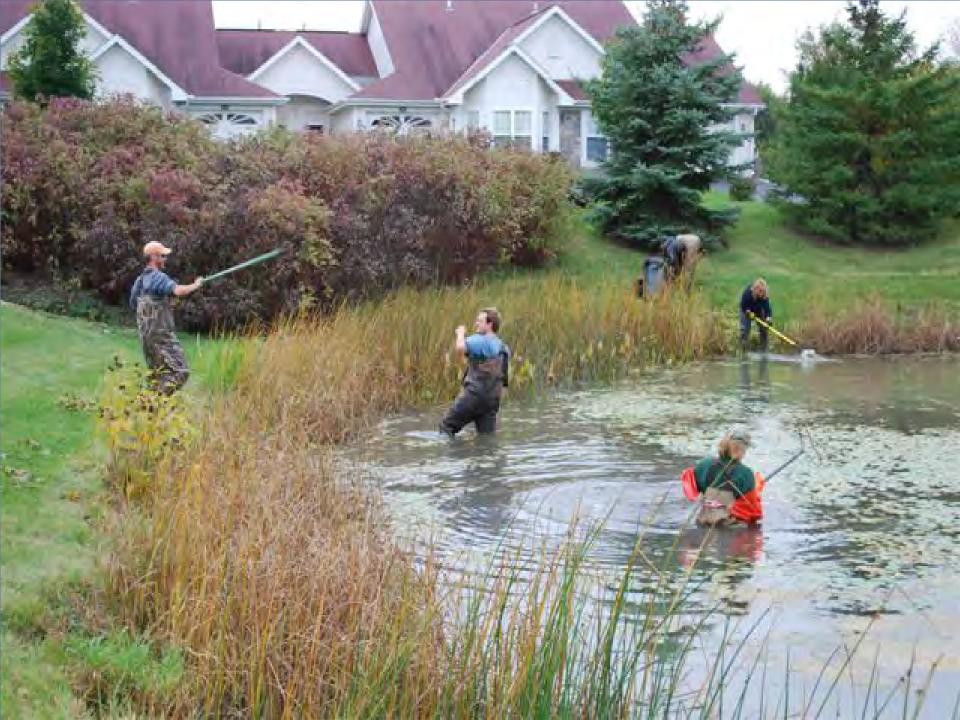
9/8/08 Both ponds have flowering YFH – DNR manually remove **biomass from South Pond** 10/7/08 DNR & Walworth County manually remove biomass and some root structure from North Pond

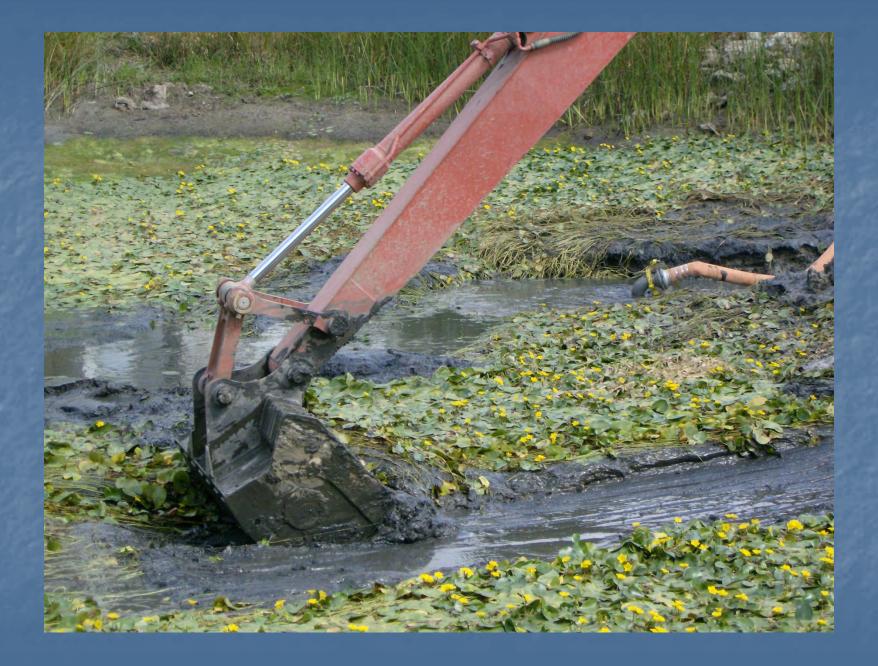
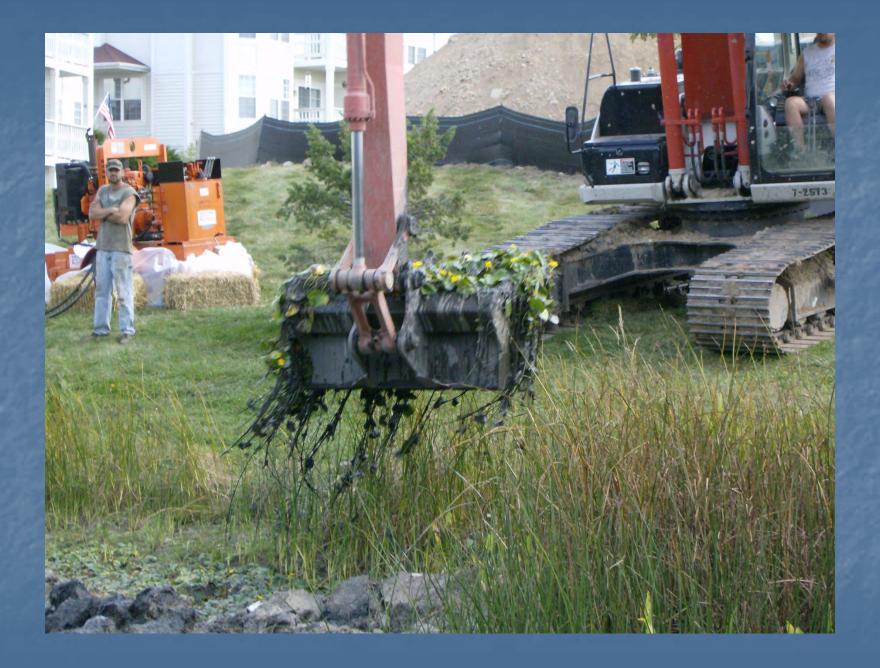
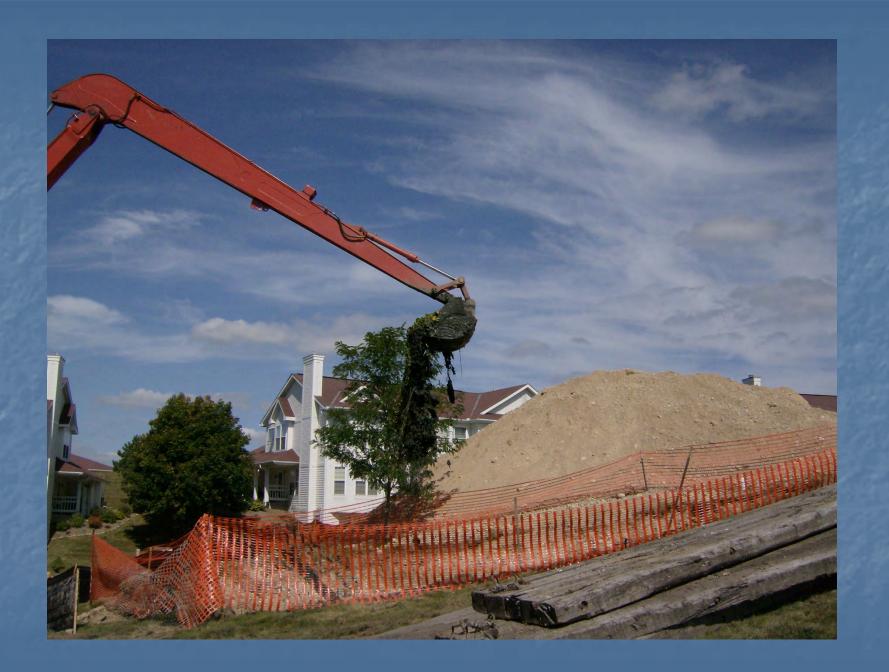
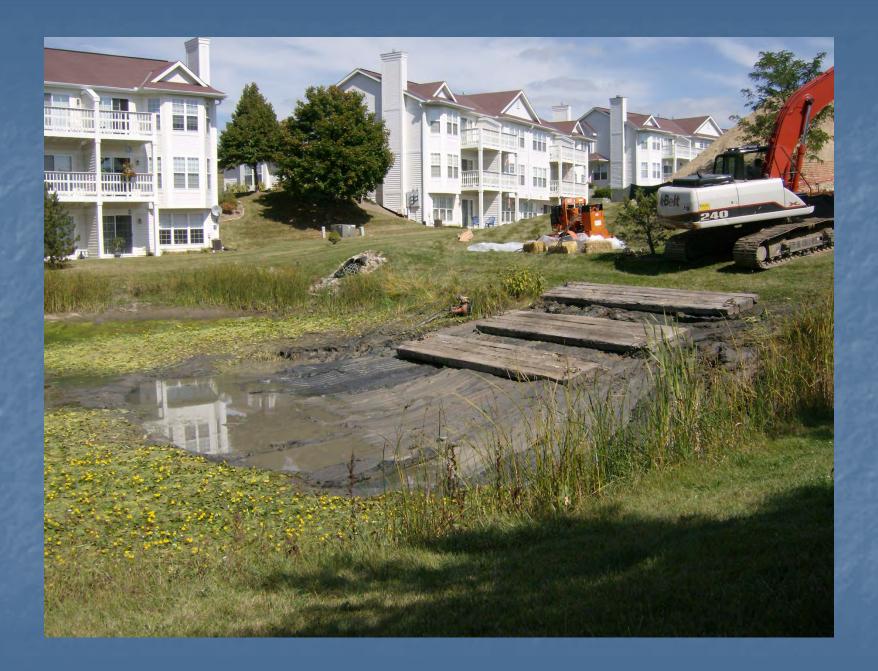
#### Dewatering 9/17 & 9/18 Time to Dewater: approx. 4 hours/pond

Dredging
- Remove all sediment
down to existing clay
liner
- shape & prep for liner

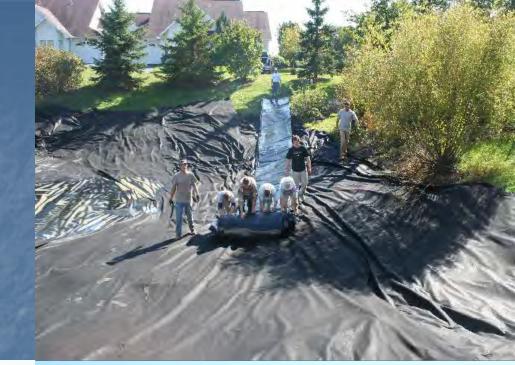
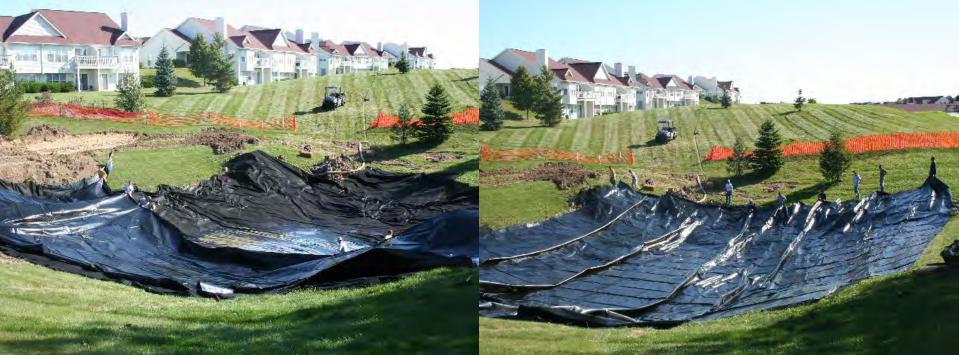
**Pond Liner** – Step 1 Under liner to protect the liner from sharp objects on bottom of ponds Pond Liner: Step 2 Liner is unfolded & laid across entire pond area

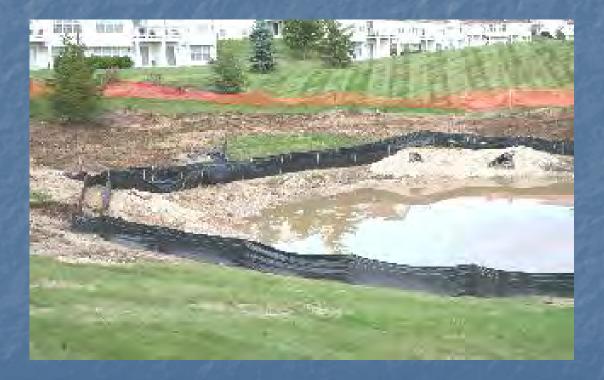
## Double Silt Fence Between Work Pad & Pond Prevents Stray Seeds from Washing Back into Ponds

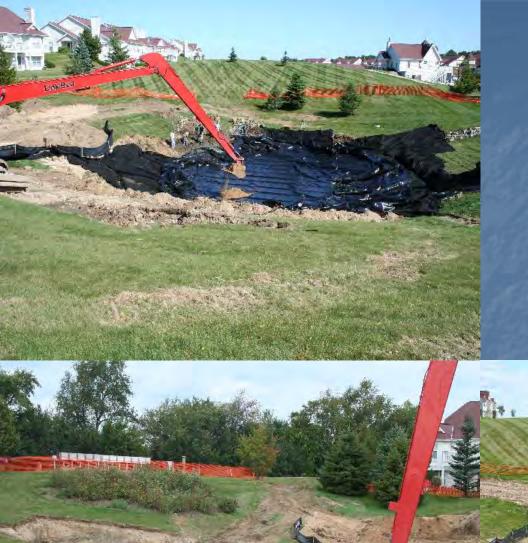
Equipment power washed over spoil pit to reduce chance of spreading YFH to other construction sites.

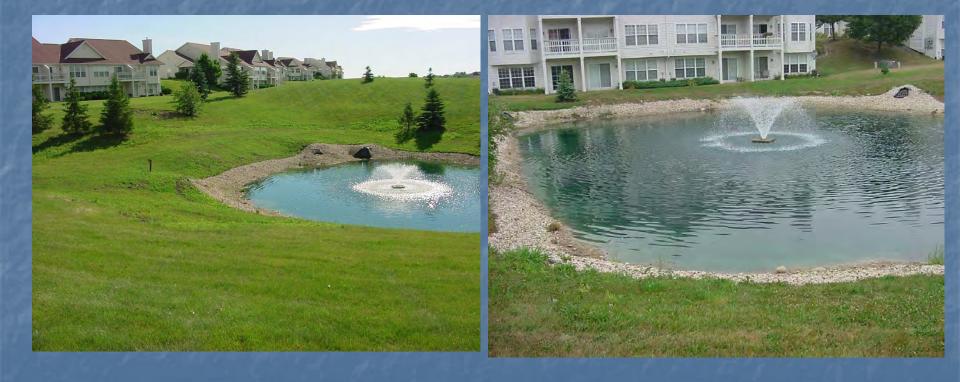
#### Pond Liner: Step 4 Soil on liner provides protection from UV rays & ballast to hold liner in place

Final Steps: Disposing of filter bags into pits Filling in (capping) spoil pits Disposal of rocks from stormwater discharge pipes into pits Final Steps: Erosion control matting Final Landscaping Spring 2010 Pictures from June 10<sup>th</sup>, 2010

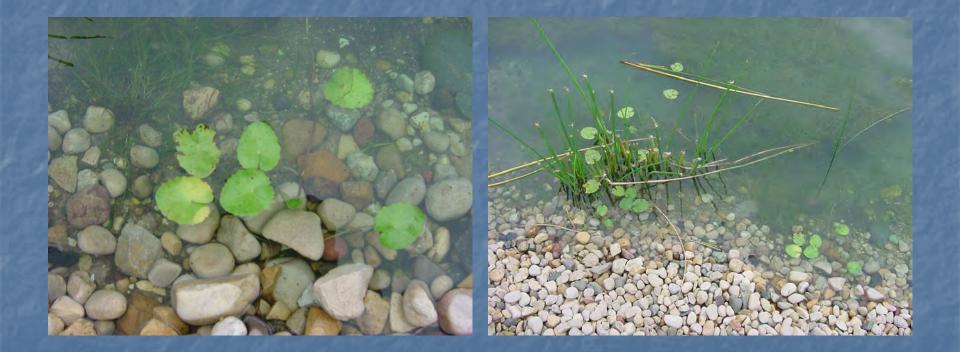
# Ponds were monitored every other week in 2010 – A few plants found September 1<sup>st</sup>, 2010 and removed
